## 74-HF Series Chem-Temp Hybrid Novolac Epoxy Performance Criteria

## Autoclave Testing Report

**Subject:** Evaluation of Organic Coatings by Autoclave Testing

**Document Number:** 1516-LS-LGSG-00-007-750 Autoclave Test Report  
With Profile

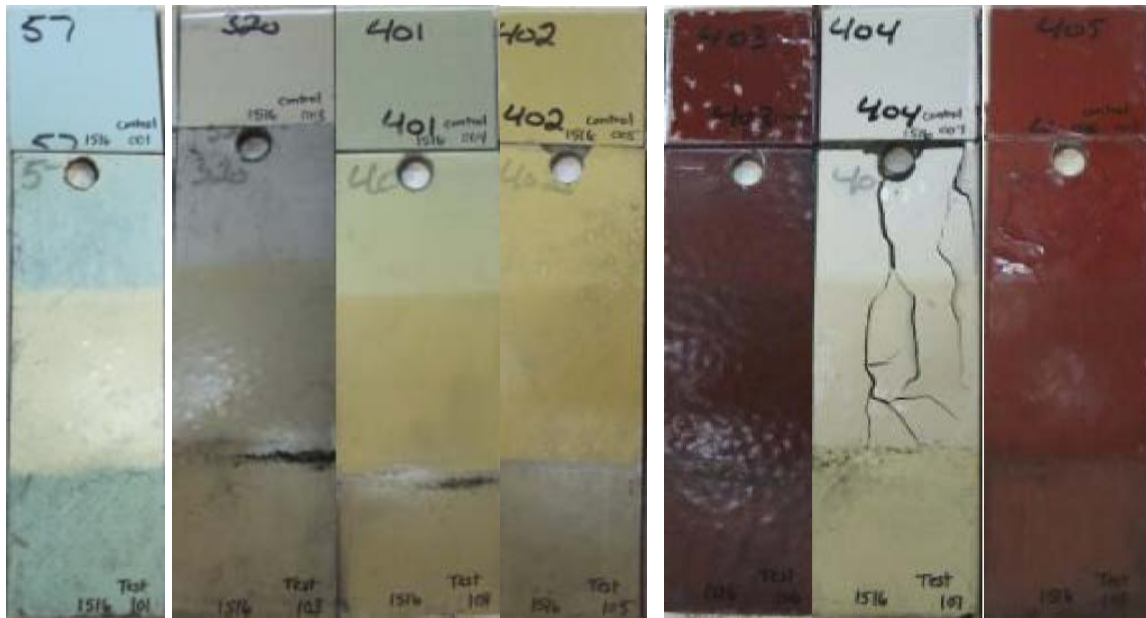
**Figure 2: Autoclave Samples – After Exposure**  
 (Left to Right: 57, 320, 401, 402, 403, 404 and 405)

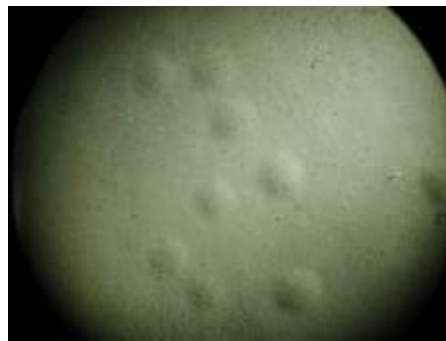
**Figure 3a: Blister Results - Panel 57 @ 7.5X Magnification**  
 (hydrocarbon phase)

| HIGH LAND Panel # | RAE Panel # | Test Phase | Pre-Test Dry Film Thickness (mils) | Post-Test Dry Film Thickness (mils) | Adhesion (NACE TMO185) | Blistering (ASTM D714) | Undercreep (NACE TMO185) | Foam | Color Change (TMO185) | Log Impedance @ 0.1 Hz (ohm*cm <sup>2</sup> ) | Comments |
|---|---|---|---|---|---|---|---|---|---|---|---|
| 57 | 1516 | 001 control | 16 | | A | | | S/F | | 10.6 | Coating appeared slightly bleached in gas and aqueous phases, severe bleaching occurred in h.c. phase. Blisters (1.5 mm to 3 mm) were observed in h.c. phase which were dry inside and did not penetrate to the substrate. No blistering in gas or aqueous phases. Control panel had excellent adhesion (no disbondment). 2 mm to 4 mm pieces could be removed mostly adhesively in all phases on the test panel, until entire test area was removed, showing a severe loss of adhesion. Undercreep testing showed adhesive removal in each phase. |

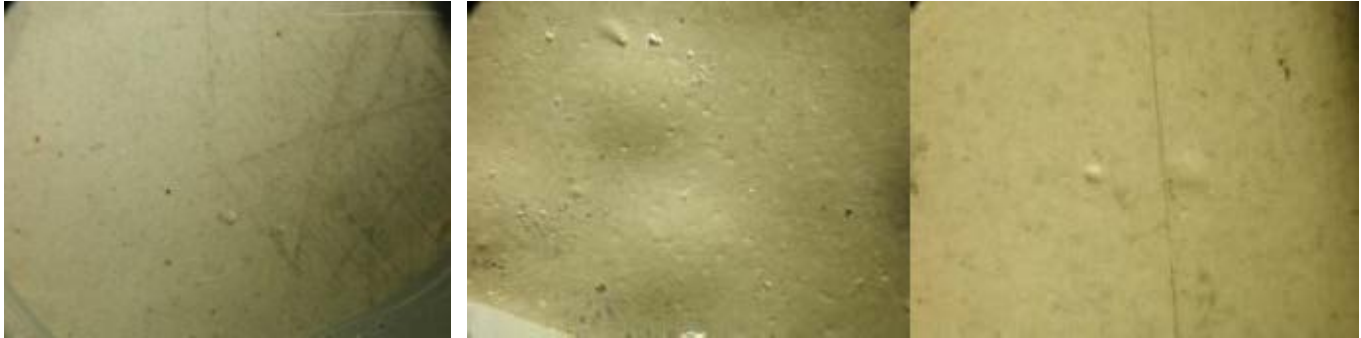
**Figure 3b: Blister Results - Panel 320 @ 20X Magnification**  
(Left to Right: gas phase, hydrocarbon phase, aqueous phase)

Coating 320 developed blisters of ASTM D714 size #4M in the gas and hydrocarbon phases. The blisters were 2 mm to 3 mm in diameter. Blisters of size #8F (<1 mm diameter) were observed in the aqueous phase of the test panel. All blisters appeared to be dry inside and did not penetrate to the substrate.

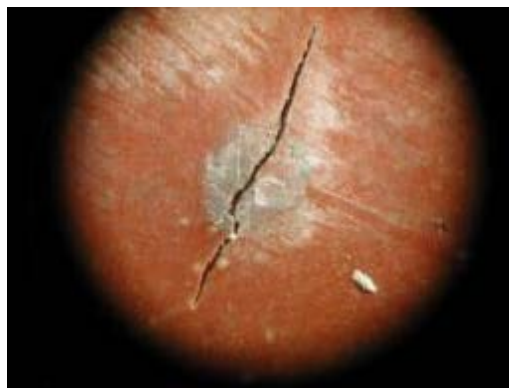
**Figure 3d: Blister Results - Panel 405 @ 40X Magnification**  
(hydrocarbon phase)

Coating 405 developed blisters of ASTM D714 size #3F in the hydrocarbon phase only. The largest blister was 3 mm in diameter and was cracked across the top. A few smaller blisters were observed in the surrounding area. All blisters appeared damp inside and penetrated to the substrate.

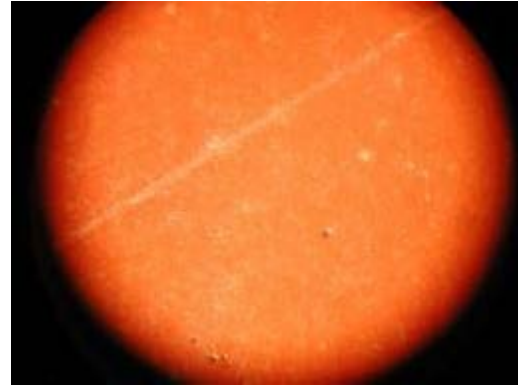
**Figure 3e: Cracking Results - Panel 405 @ 40X Magnification**  
*(Left: gas phase, Right: hydrocarbon phase)*

Severe cracking occurred across the entire coating surface in the gas phase. A single crack was observed diagonally across the surface of the hydrocarbon phase. The cracks appeared to penetrate to the substrate, although the surrounding coating remained adhered to the substrate.

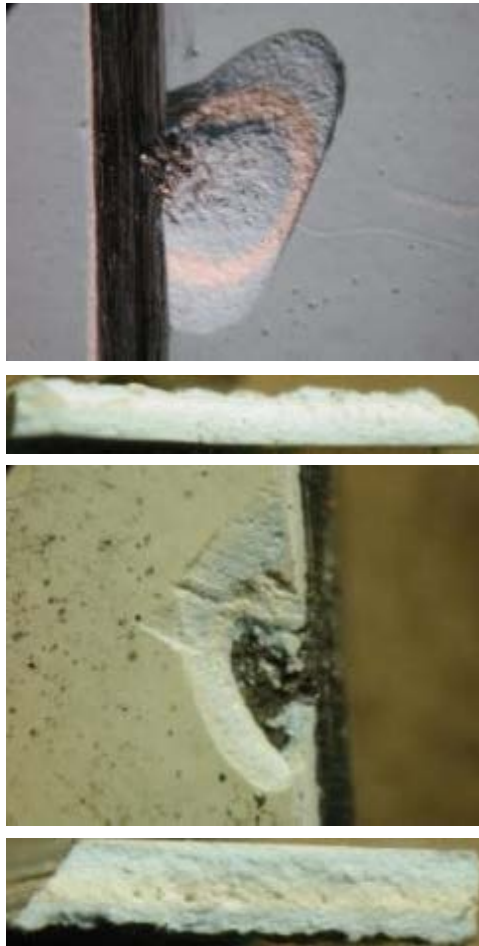
**Figure 6a: Foam Results for 57 @ 40X Magnification**  
(Top to Bottom: control, gas phase, hydrocarbon phase and aqueous phase)

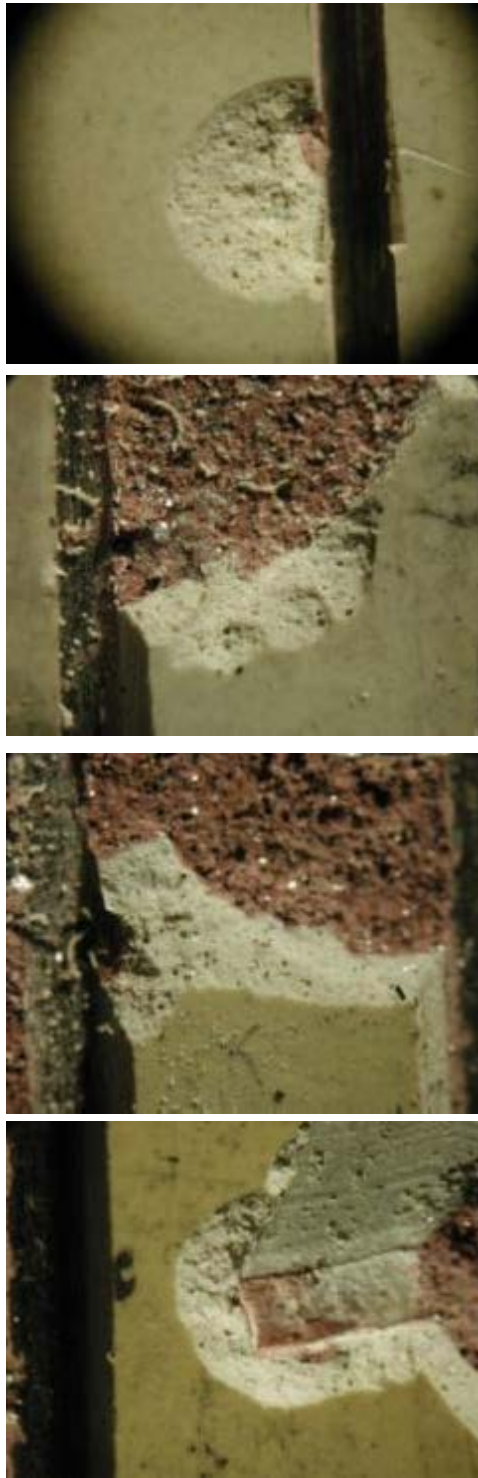
**Figure 6b: Foam Results for 320 @ 40X Magnification**  
(Top to Bottom: control, gas phase, hydrocarbon phase and aqueous phase)
